Warringah Freeway Upgrade

Design & Construction

Peter Carson & Tim Hodge

March 2025

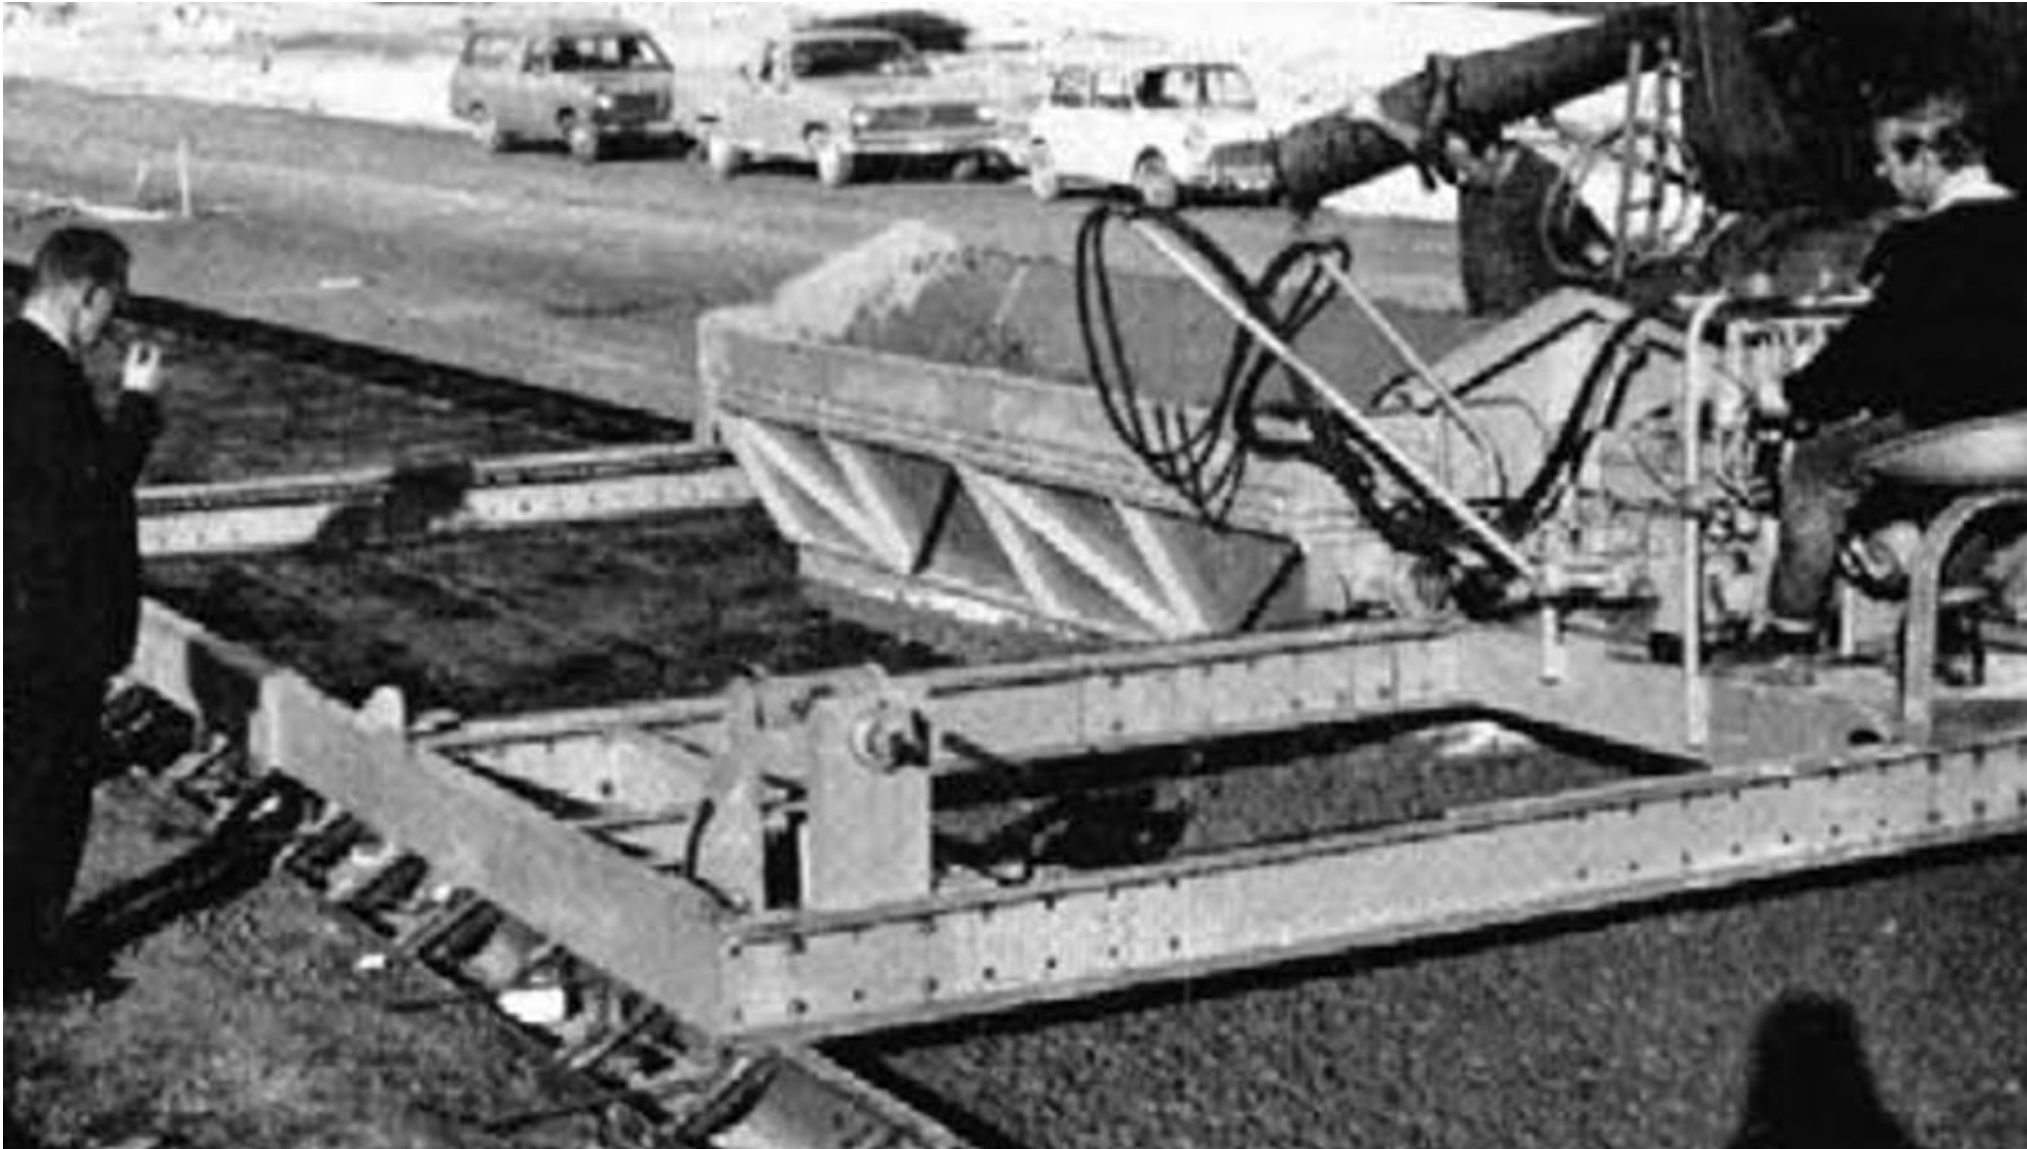
Spreading first 100mm of concrete base

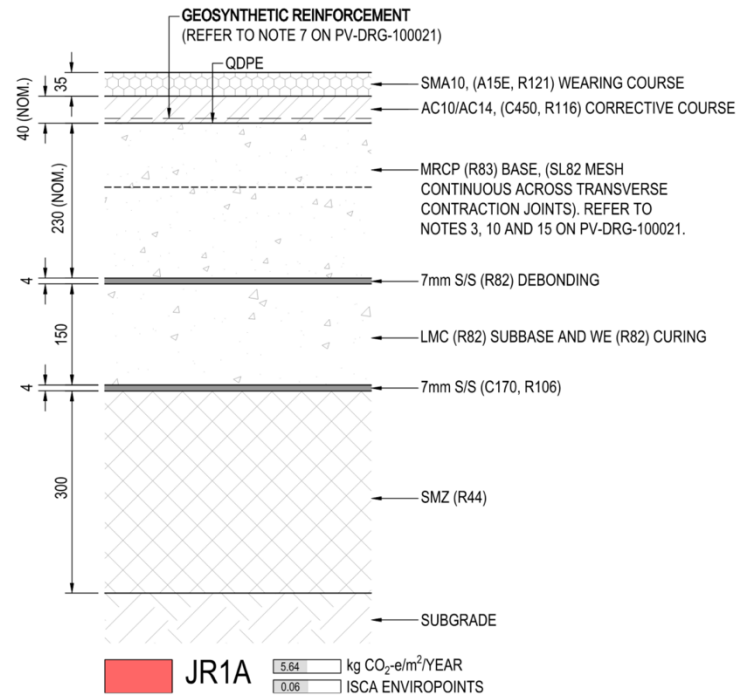
Mainline Pavement Profile – Detailed Design

Non-standard
concrete pavement
– coined 'MRCP'

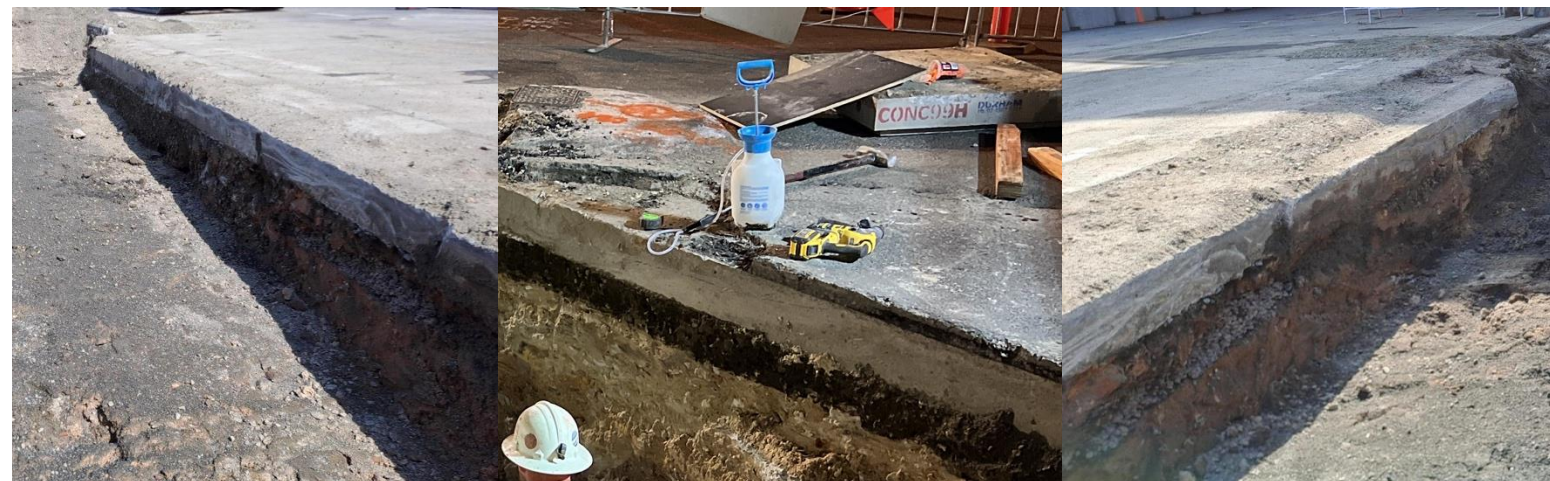
- What we did find was surprising!

Well for an almost 60 yo pavement

- Pretty much what we were told to expect
 - ~220mm concrete base
 - ~150mm stone subbase
 - ~300mm clay/select material backfill

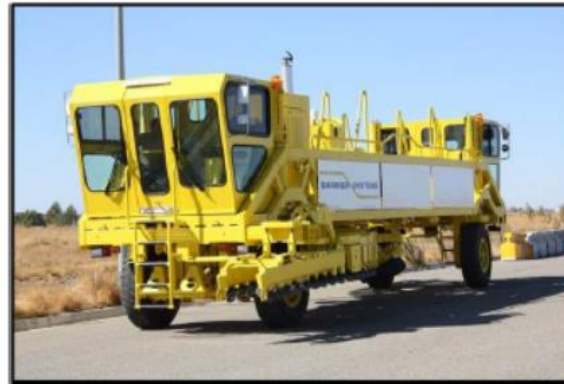
18" RTS Barrier

- Reactive Tension System (RTS) Barriers (concrete)
- Barrier Transfer Machine (BTM) lifts barriers by the "T-Top"
- Variable Length Barriers (VLBs) allow for barrier relocation, radius curves & expansion joints (VLB ratio is determined for each project individually)
- Absorb crash cushion - unanchored & transfers through the BTM with barrier

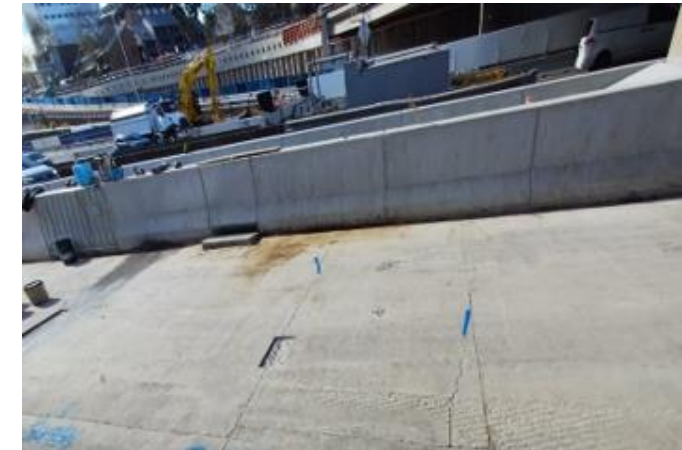
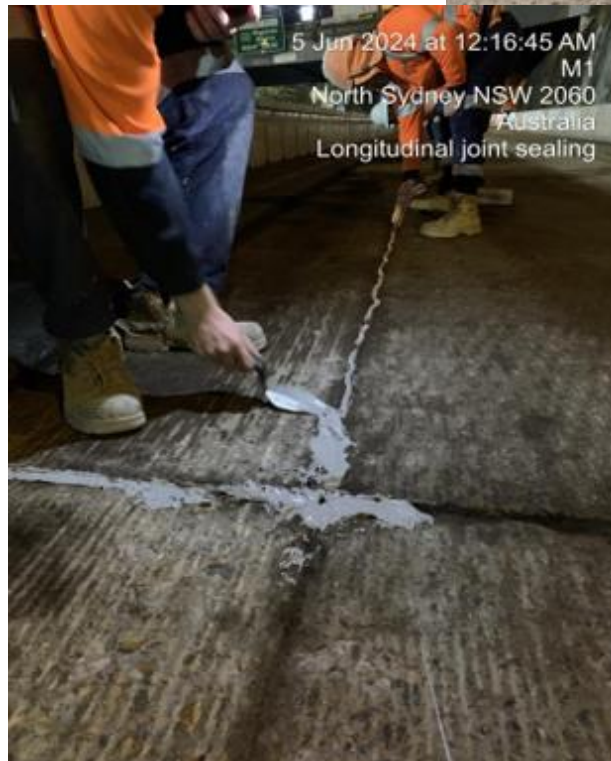
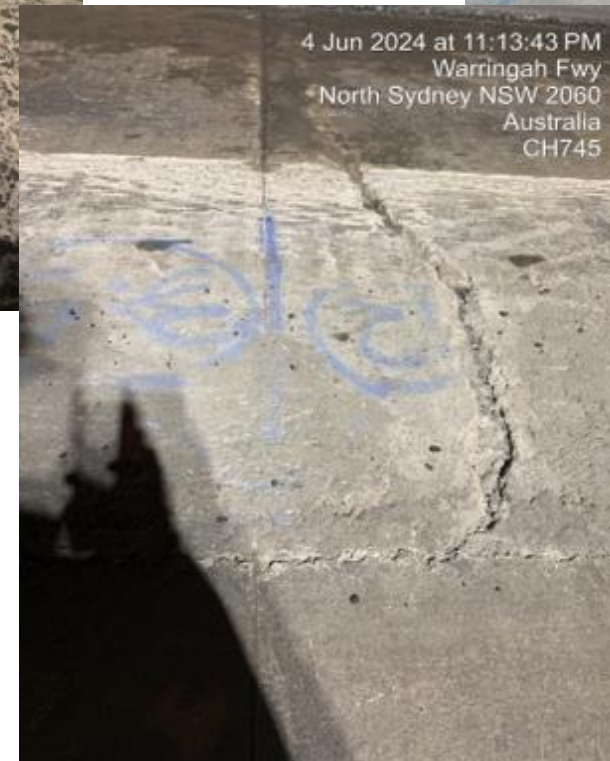
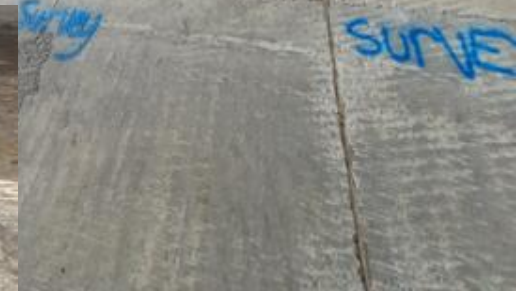
- Unknown pavement faults
 - Part & full slab replacements
 - Joint repairs & re-sealing

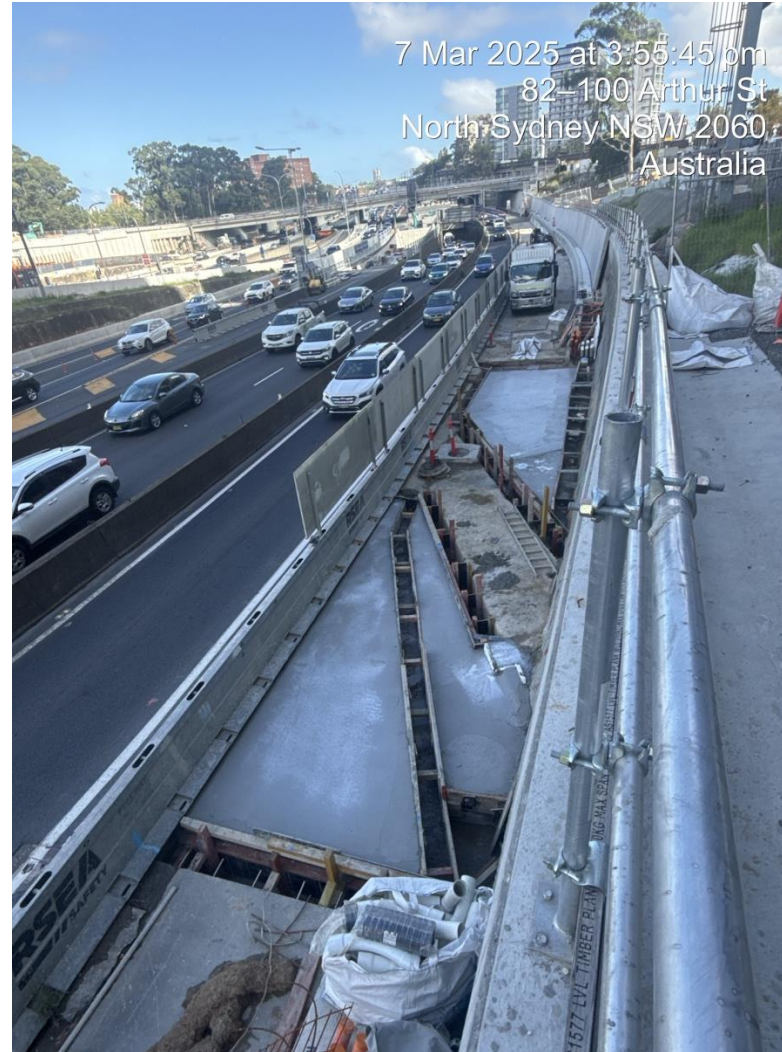
- Careening Cove Culvert:
- Careening Cove Culvert runs diagonally under Warringah Freeway, Nth Sydney;
- Information indicated there was rigid pavements over and on approach to culvert;
- When exposed only a thin layer of AC found over culvert;
- Compromised pavement design incorporating existing condition required to be created to resolve problem.

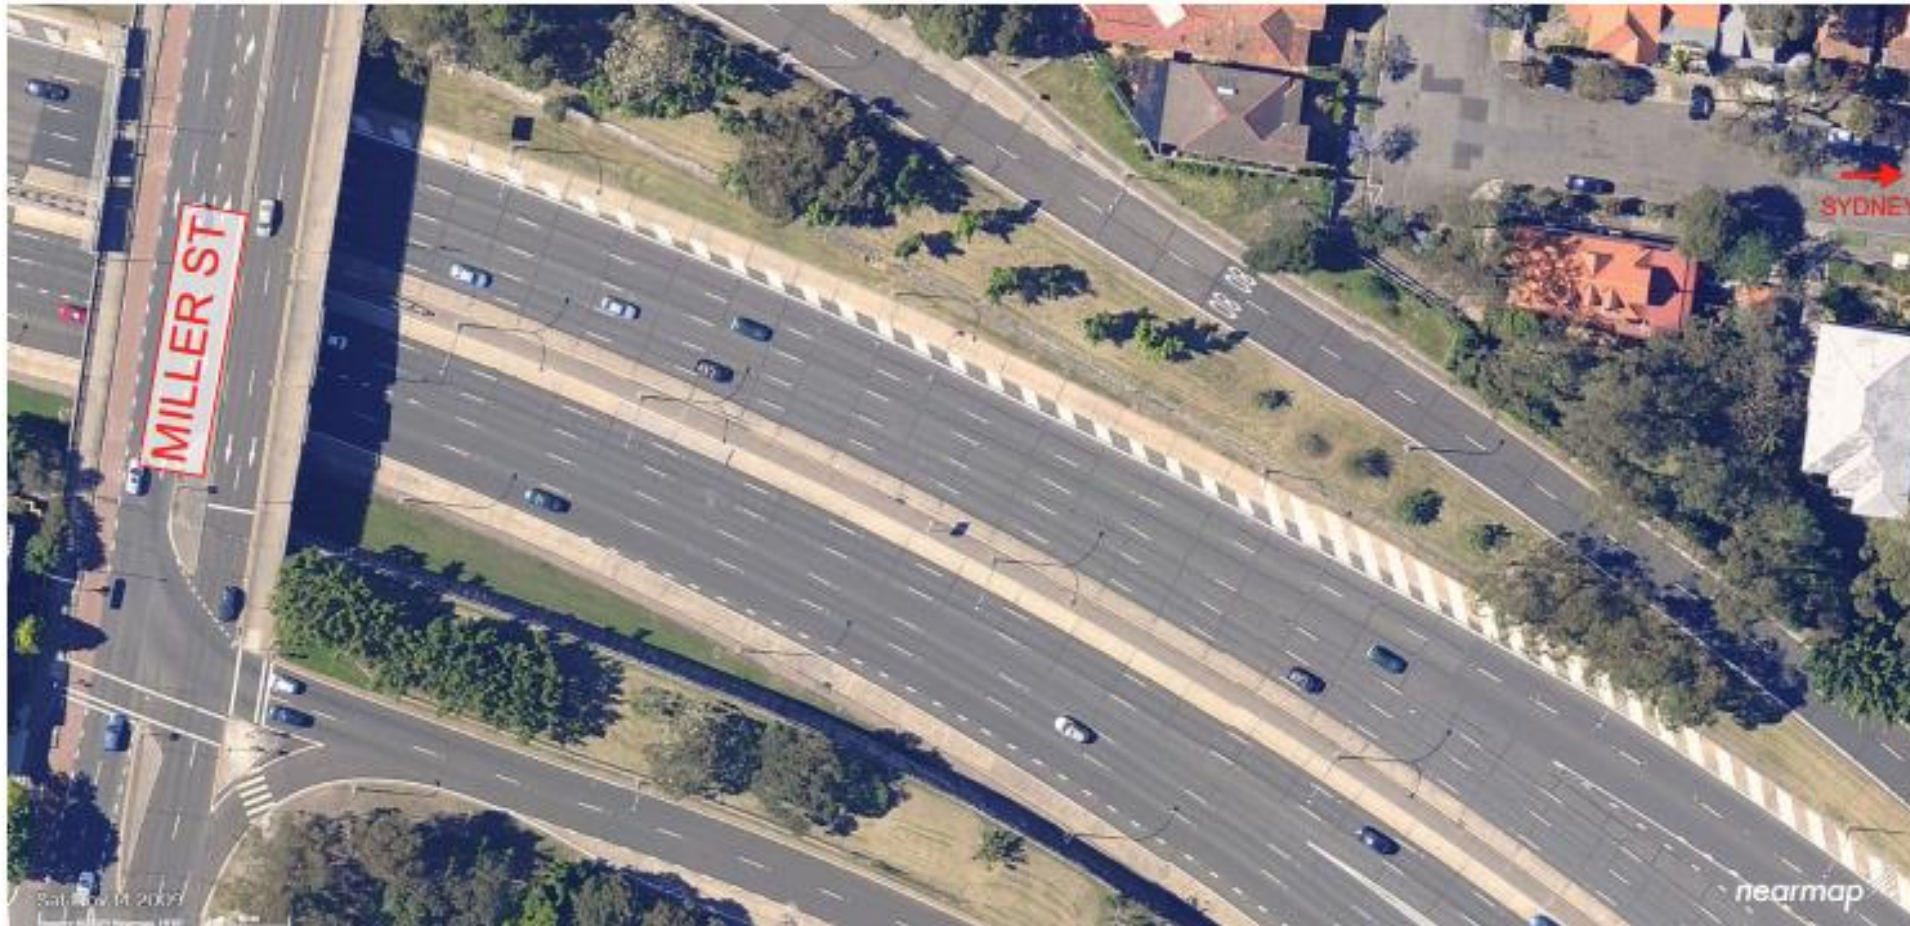
14 Nov 2009: SB carriageway has been sawcut & sealed

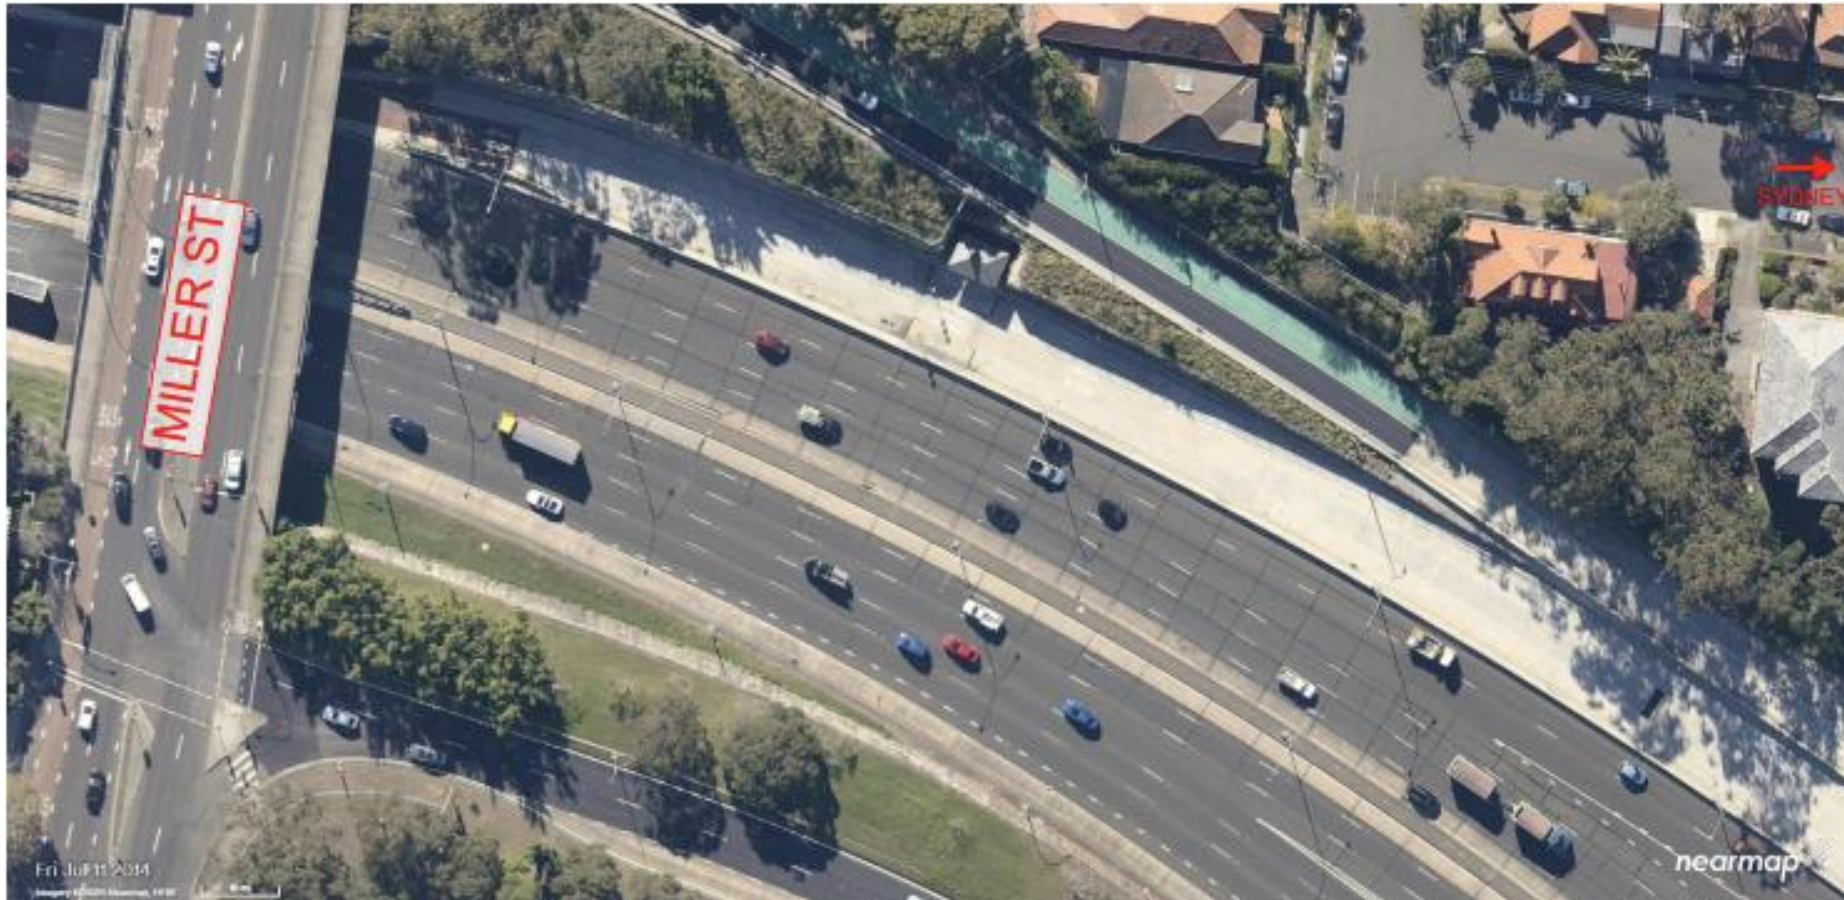
11 July 2014: No change, no maintenance for 5 years
